PREVENTIVE CONSERVATION
PRACTICE IN THE FIELD OF BUILT HERITAGE

PREVENTIVE CONSERVATION OF CHURCHES DURING TUNNEL WORKS IN STOCKHOLM

Henningsson Anna

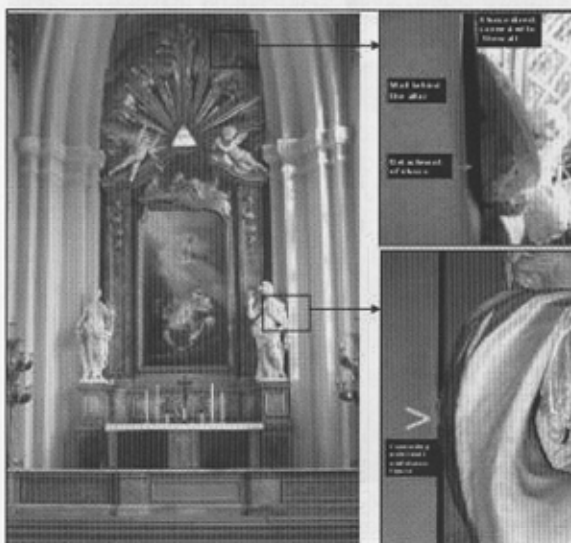
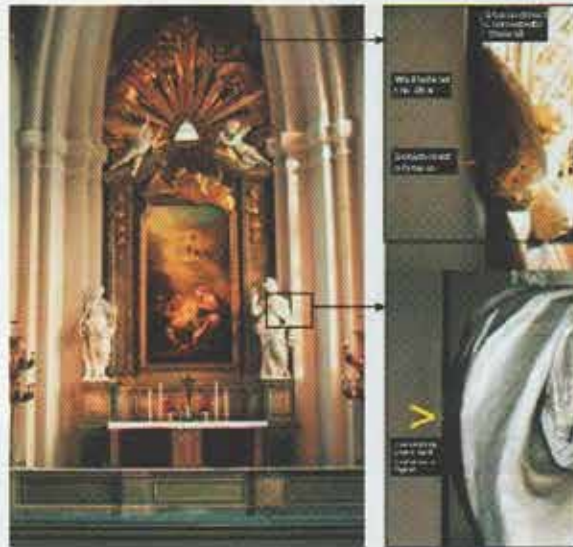
Fig. 1: Examination of the wall-integrated altar in Maria Magdalena church. Zones where the altarpieces have a direct connection to the wall. Photo: A. Henningsson

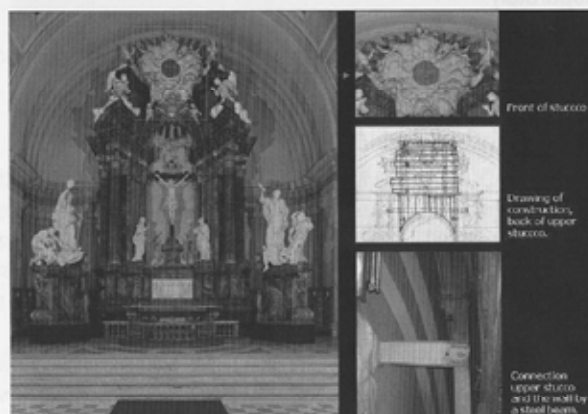
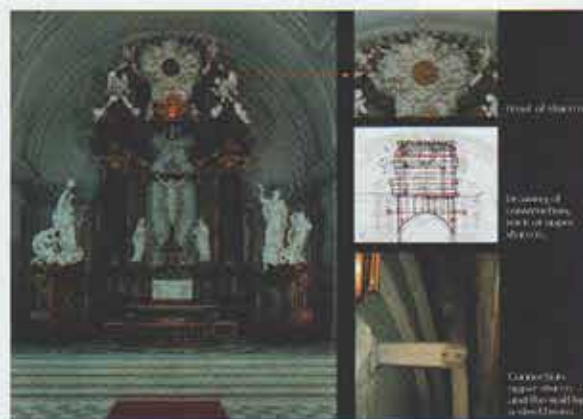
The altarpieces were especially singled out as high-risk objects. The fact that they are totally or partly fixed to the floor and surrounding walls makes the transportation of vibration direct. Two of the altars are mainly composed of stucco gilding and paint layers. Materials such as wood, glass or painted canvas are partly recessed in the construction, which makes it a complex system. A notable artifact is the baroque high altarpiece in the Gustaf Vasa church, with a height of 15 meters and composed of painted and gilded wood and stucco elements. As this altarpiece was moved from another church in 1905 some constructive replacements

were made and today it is connected to the wall by steel-beams.

Fig. 2: Part of visualisation of the construction and wall integration of the high altar in Gustav Vasa church.

The project definition of direct preventive conservation solutions has a remedial character and involves direct action on the artifacts by a conservator. As opposed to "traditional" remedial intervention or treatment, the direct preventive conservation solutions are mainly temporary solutions during the tunnelling work. A direct preventive solution within this project is to create temporary facings over certain risk zones of the artifacts for example stucco or plasters. Further, vibration-damping solutions on artifacts are defined as direct preventive conservation solutions. In the case of the baroque altar in Gustaf Vasa church a reversible

construction to damp or interrupt the vibration before they reach the object is being developed.

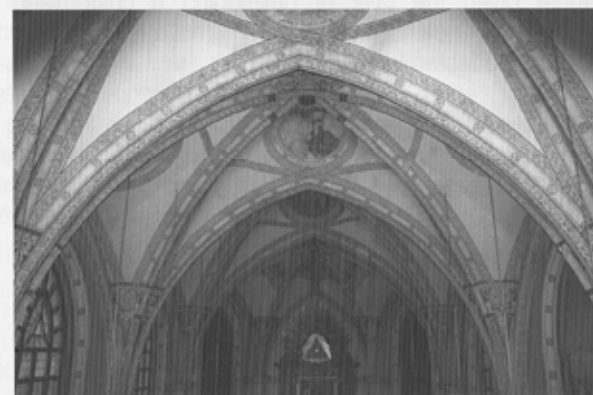
Three-dimensional architectural surface details built up of lime or gypsum such as stucco figures and reliefs, integrated tombs, epitaphs, brackets, capitals and rib of vaults are also defined as risk areas. (Figs. 3-4). These elements are partly integrated into vaults and walls depending on the type of construction. Cracks and cavities in plaster, stucco and wall paintings can be aggravated in a vibration-exposed environment and potentially result in detachment.

Fig. 3: The mural paintings and decorated plaster on the rib vaults in Clara church. Photo: A. Henningsson

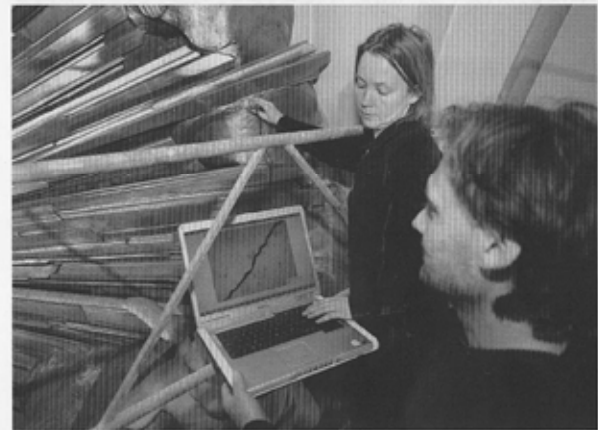
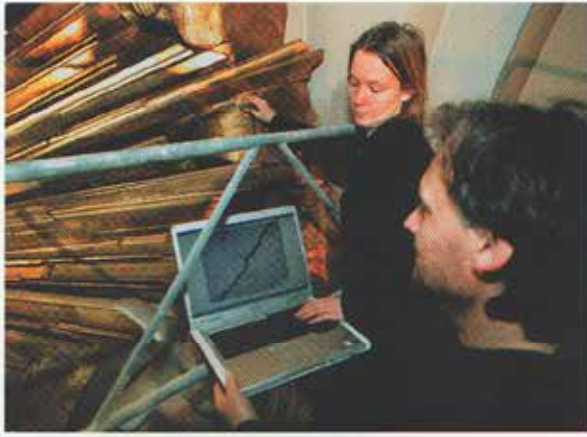
The monitoring is based on the mapping of cracks and cavities, logging of cracks widths as well as fixing points of artifacts in the structure. These parameters will be regularly evaluated and correlated with continuous vibration measurements. (Fig. 5-6). Conservators with adequate specialization are controlling these monitoring areas. In addition an interdisciplinary overall evaluation takes place in the working groups.

Fig. 5: Measuring crack width in stucco using microscope. Photo: H. Ekestang

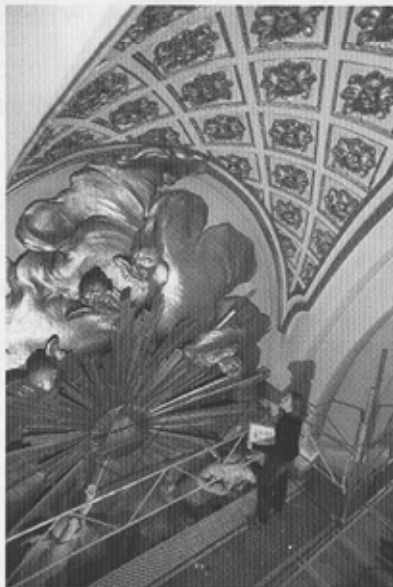
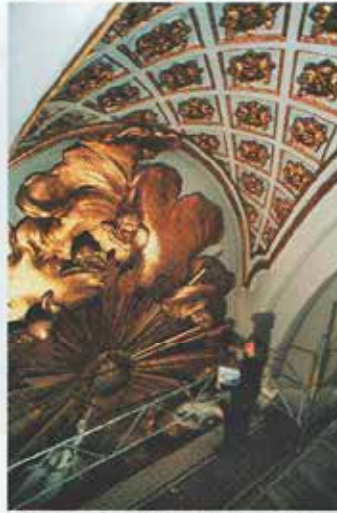
Fig. 6: Condition survey by mapping of the stucco altar in Maria Magdalena church. Photo: H. Ekestang

Fig. 6: Condition survey by mapping of the stucco altar in Maria Magdalena church. Photo: H.
