HET ONZICHTBARE RESTAUREREN RESTAURER L'INVISIBLE

BRK - APROA / ONROEREND ERFGOED STUDIEDAGEN
JOURNÉES D'ÉTUDE APROA - BRK / ONROEREND ERFGOED

PRESERVING HIDDEN AND FORGOTTEN MURAL PAINTINGS ABOVE THE VAULT IN CHURCHES IN SWEDEN | ANNA HENNINGSSON

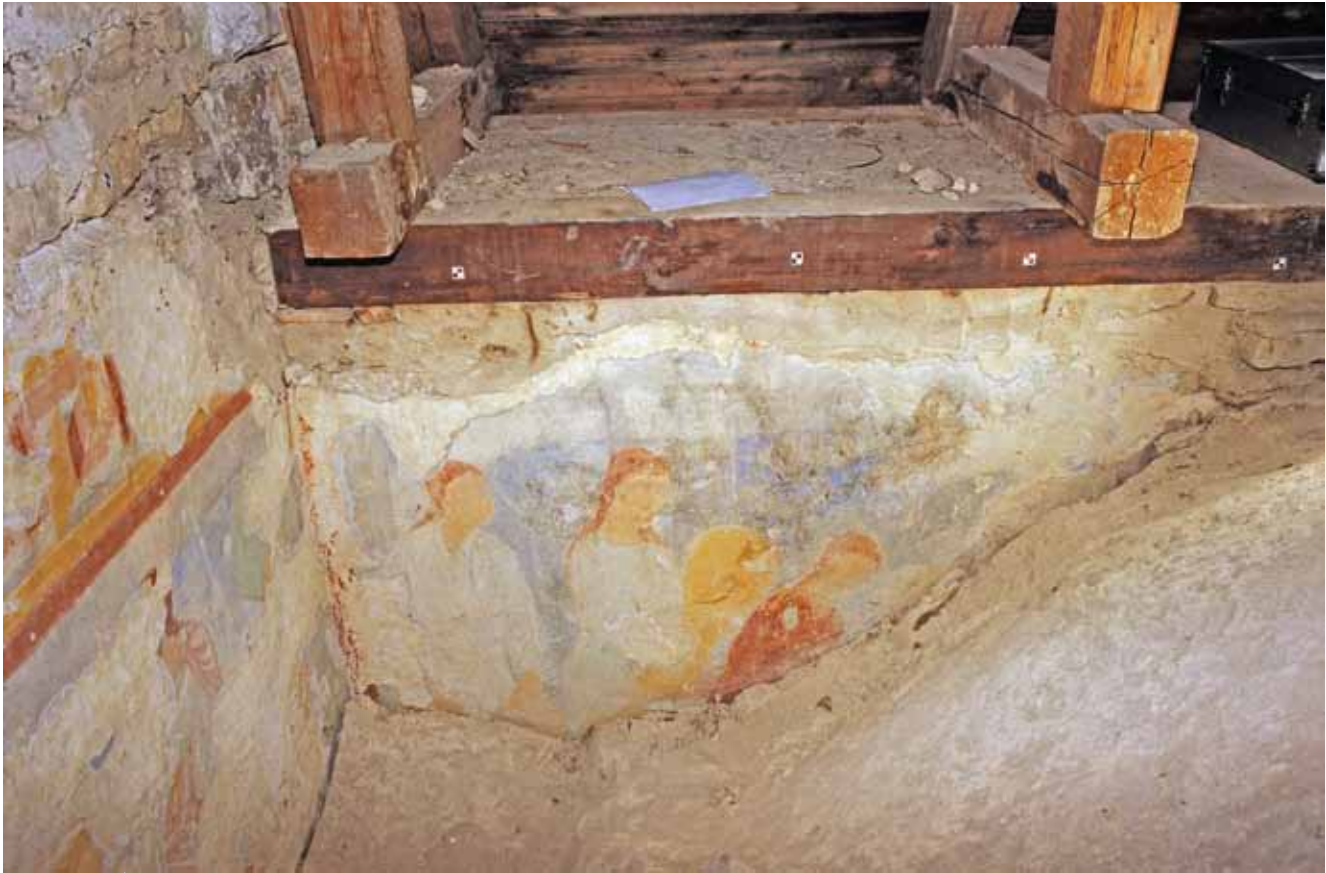
Part of the Romanesque murals above the choir vault in Fornåsa church in the county Östergötland, Sweden (photo A. Henningsson)

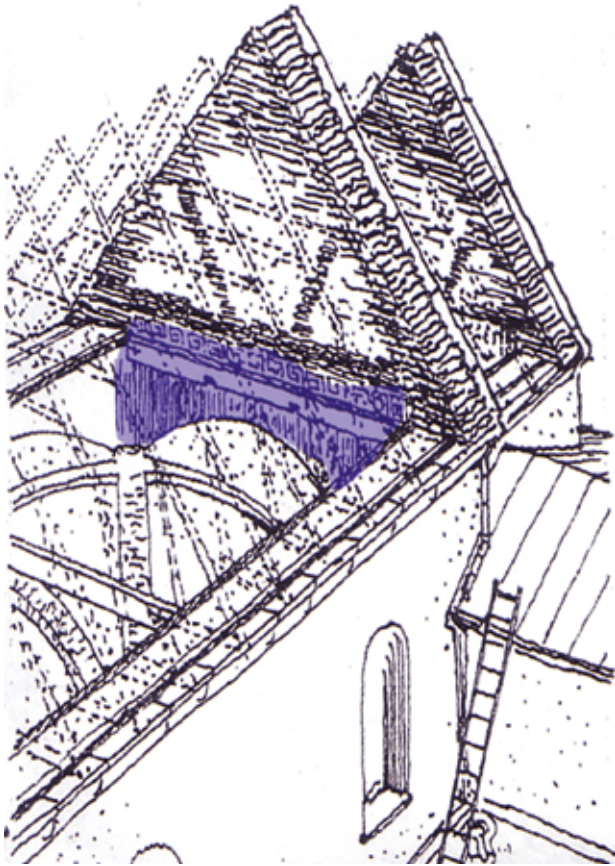
The drawing shows where the murals are located in the church attics (the colored area): drawing from Fornåsa parish archive by A. Philip in 1953

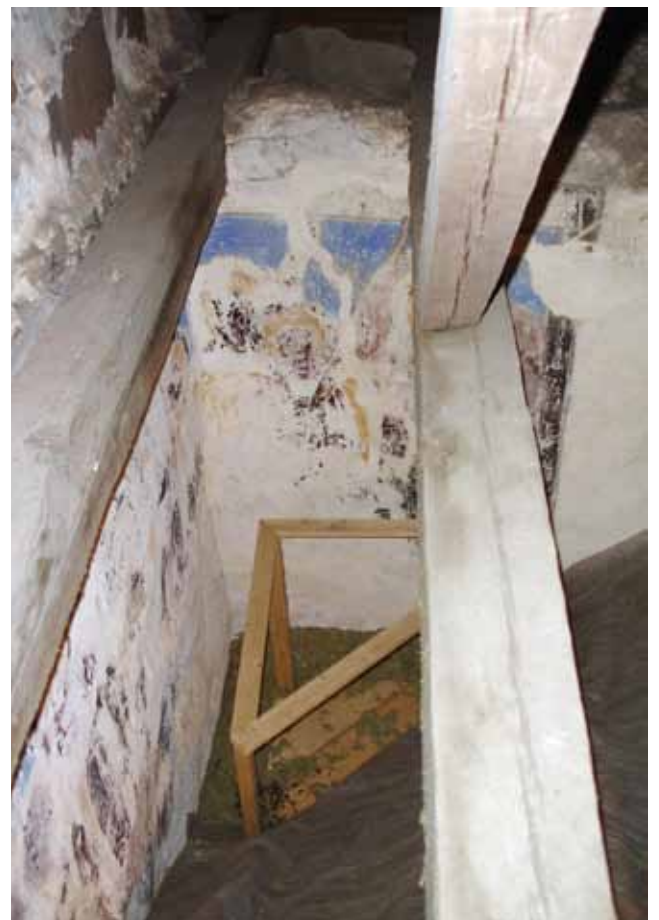
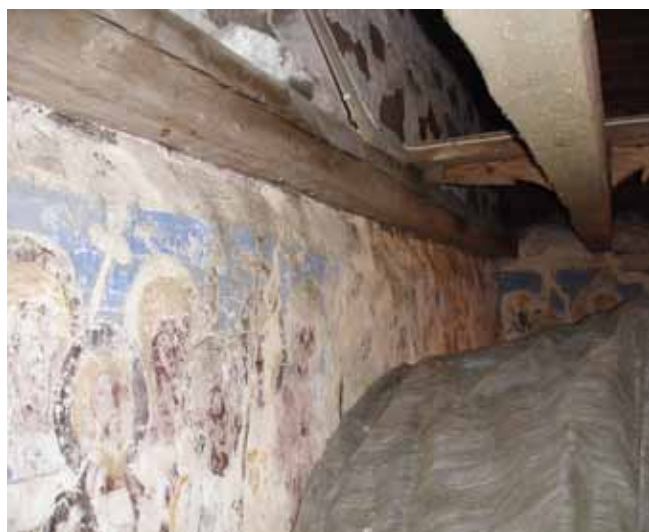
Result of photographing at site without rectification: parts of the painting scenes are shadowed by the vault, roof construction and the permanent scaffolding (photos A. Henningsson)

The photographer's ability to move is very restricted. The absence of regular floor excludes the use of a tripod. It is not possible to keep the same distance between camera and wall since the upper parts of the vaults are partly shadowing the motives. The only way to get an overview photo of these paintings is to apply digital photogrammetry. The result of the rectification is a true to scale photomap. The initial single part images of the painting are shot with a digital mid-format camera. These single images taken from different distances and angles include a lot of perspective distortions. The distances in the murals have to be measured by a reflector-less electronic tachometer to enable a rectification of perspective distortions. The rectified single pictures were finally assembled to an overview photo in the scales 1:5, 1:10 and 1:25. ^[3].

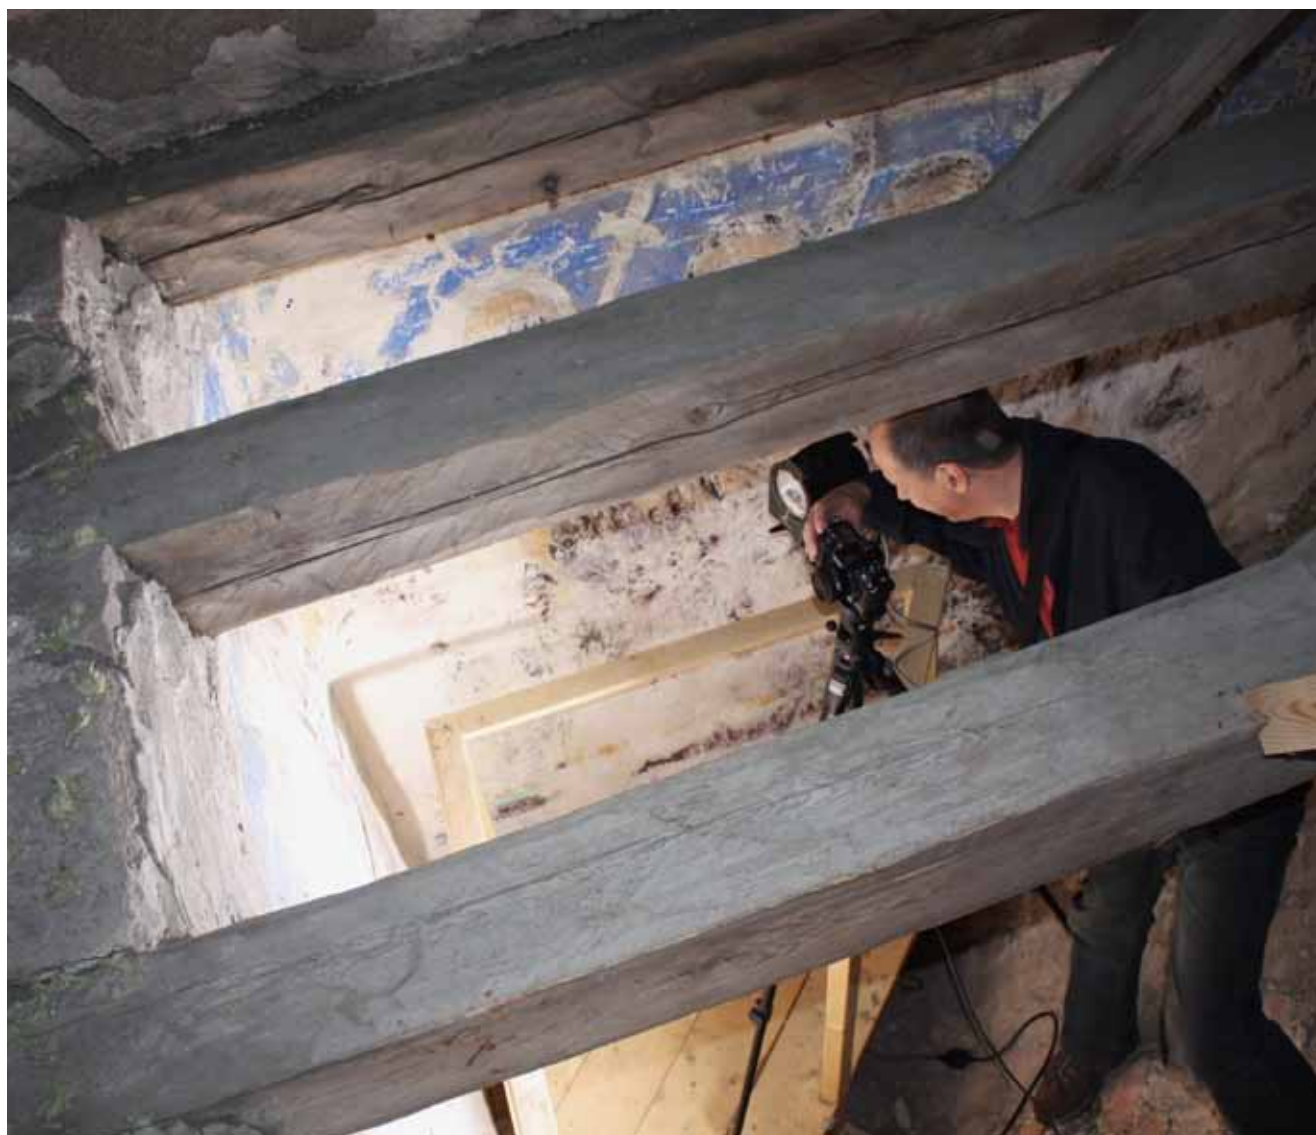
Photographing at site for creation of scale true photo base maps (photo A. Henningsson)

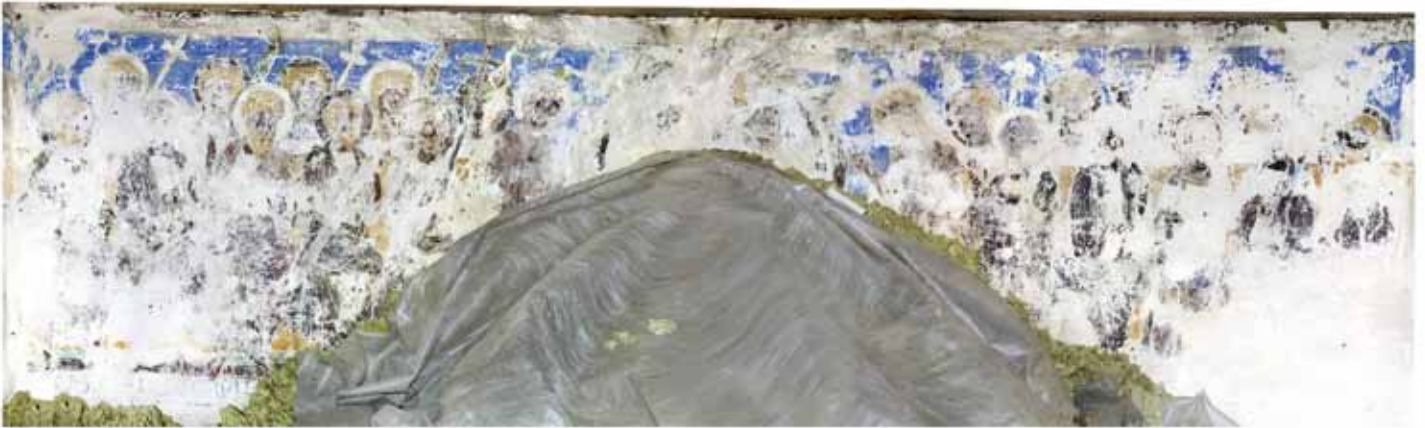
Rectified photo base map in scale 1:15 of the murals on the east wall in Skönberga church, Östergötland (photo Fokus Leipzig GmbH)

The rectified photo plans were the base maps for all documentation during the examination of painting technique. The rectified photographs enable a study of the paintings details and contents from a frontal view without perspective distortions. The initial examinations focused on the registration of traces from the execution process. By using frontal and raking lightning with a color temperature of 5400 K, traces from the creation process could be revealed. The findings were documented with high resolution photography. With support from observations in ultraviolet light, character and technological evidences in the paint layers were found. By using a portable microscope with a magnification up to 200x at the site, a micro examination of the surface character and layer stratigraphy was accomplished. The locations of these painting technological findings were mapped to the rectified base map photographs. The visual examination resulted in a photo catalogue over the technological findings from the execution process of each mural.

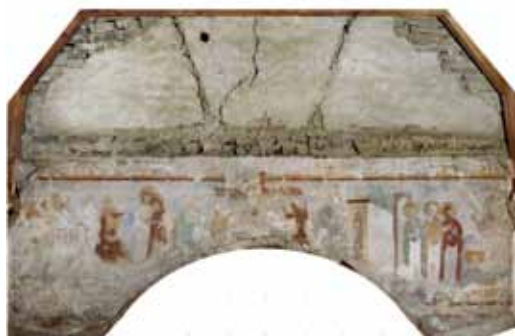
The Romanesque mural painting on the east wall on the attic of the nave in Fornåsa church, Östergötland (photo Fokus Leipzig GmbH)

Above the vaults, in the loft of the nave, three scenes from the Passion of Christ are depicted⁽¹¹⁾. The capture of Christ, Christ on the cross and the women by the sepulcher cover an area of 12 m² on the upper eastern wall of the nave above the tribun arch. The three scenes are depicted on a blue background and a palmette border frames the upper part of the painting. The mural is stylistically dated to the last quarter of the 12th century⁽¹²⁾.

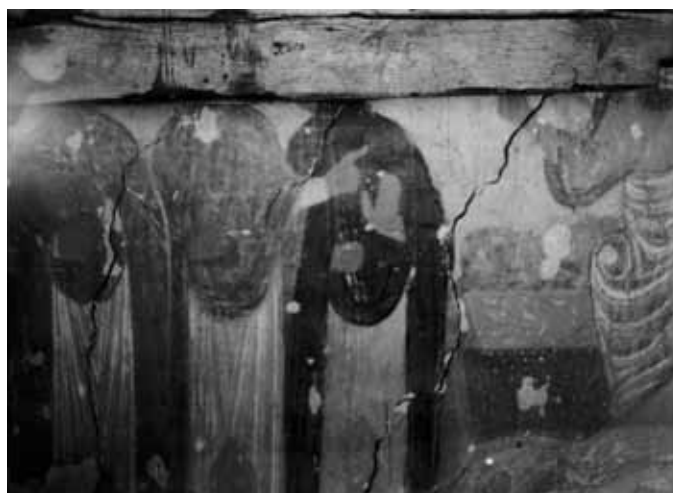
Photo from Fornåsa parish archive showing the beam in the roof construction that was added in 1900 and hiding parts of the murals until 1954 as it became removed

After the discovery the wall paintings became partly concealed again as a new beam was added in a roof stabilization process in 1900. Fifty-four years later the murals were completely visible again as this beam was removed. In the 1950s art historians studied the wall paintings above the vaults in the nave and the choir vault. An extensive stylistic study was carried out in the fifties by Borelius ^[10]. Explorations of painting techniques and used material were for the first time initiated in year 2003.

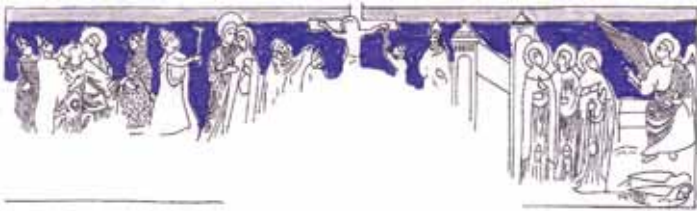
Drawing of the scenes on eastern wall of the nave, by Sörling in 1955

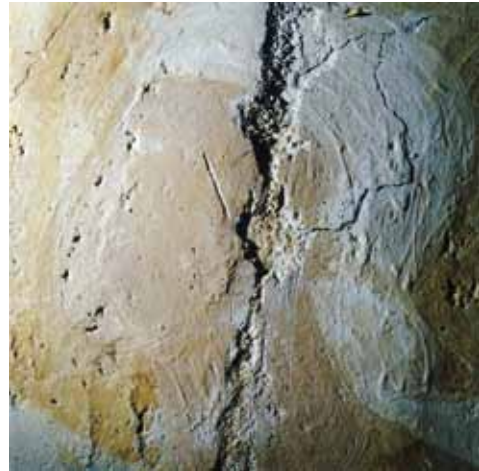
Through lacunas in the 2 mm thick intonaco an arriccio of 8 mm can be seen. Further a 1 mm thick lime wash layer is applied to the arriccio (photo A. Henningsson)

The arriccio is applied on a support of masonry consisting of an uneven, untreated variety of Orthoceratite limestone from the villages around Fornåsa. Through lacunas in the 2 mm thick intonaco an arriccio of 8 mm can be seen. A 1 mm thick lime wash layer is applied to the arriccio. Visual examination and comparison of the stratigraphy of the plaster layers revealed that unlike the east wall, the south and north wall did never have an intonaco. Thus all three walls share the same type of arriccio with a richly added 1 mm lime wash. The absence of traces from an intonaco layer on the south and north walls indicate that there was no intention to paint these walls in the same technique as the east wall. The observation of the rounded plaster bridge in the corner to the east wall proves that the arriccio of the three walls were executed at the same time. The intonaco is carefully smoothed with a metal trowel which has left regular marks in the plaster surface sized 1x4 cm. Evidence of the plaster being added in patches was not observed. On the intonaco a thin and partly pastos lime ground is added. The first layer of paint was added as the lime ground was still moist.

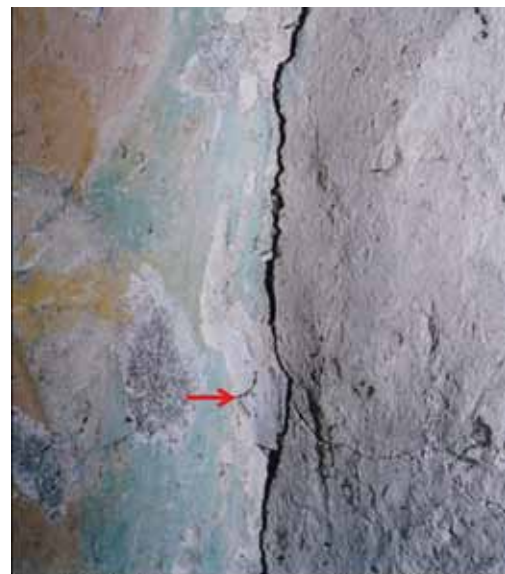
East wall

South wall

The plaster edge in the connection between the east and the south wall. The rounded corner to the east wall proves that the arriccio of the three walls were executed at the same time. The absence of traces from an intonaco layer on the

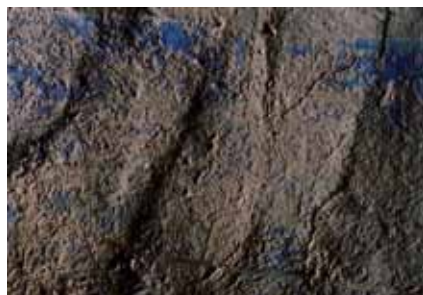
The surface character of the intonaco: traces after tool marks from the smoothing process of the intonaco (photo A. Henningsson)

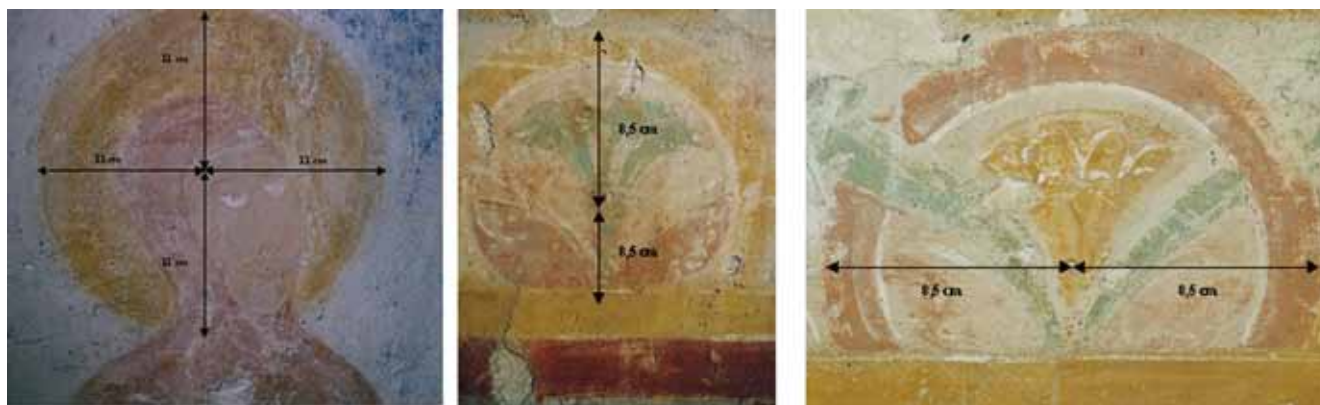
Measurement of distance from compass points to the outside of the circles showed that exact repeated distances have been applied (photo A. Henningsson)

Only a few evidences from controlling the geometry of the composition could be established in this case. Evidences for a preparatory drawing, sinopia or snapped lines was not found in Fornåsa church. Rich findings of compass points set in the moist intonaco lime ground were found. This shows that the geometrical elements in the palmette board, as well as the heads and nimbus of the three women were executed with the aid of an indirect compass^[14]. The absence of incisions excludes the use of a direct compass. The heads of the figures and the half circles in the palmette board have a consistent distance from the compass point to the outline of the circle.

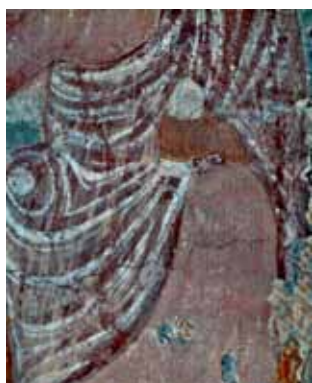
The modeling highlights of the angel's robe are well preserved and have a pastos appearance (photo A. Henningsson)

women are rare to find. Negative signs of modeling layers in some robes these are partly visible in magnification. The remaining of a white outline of the robes has been observed. The modeling effects of the angel's robe are well preserved in comparison with the robes of the three women. The highlights in white have a pastos appearance and are applied on the pink shadows in the robe.

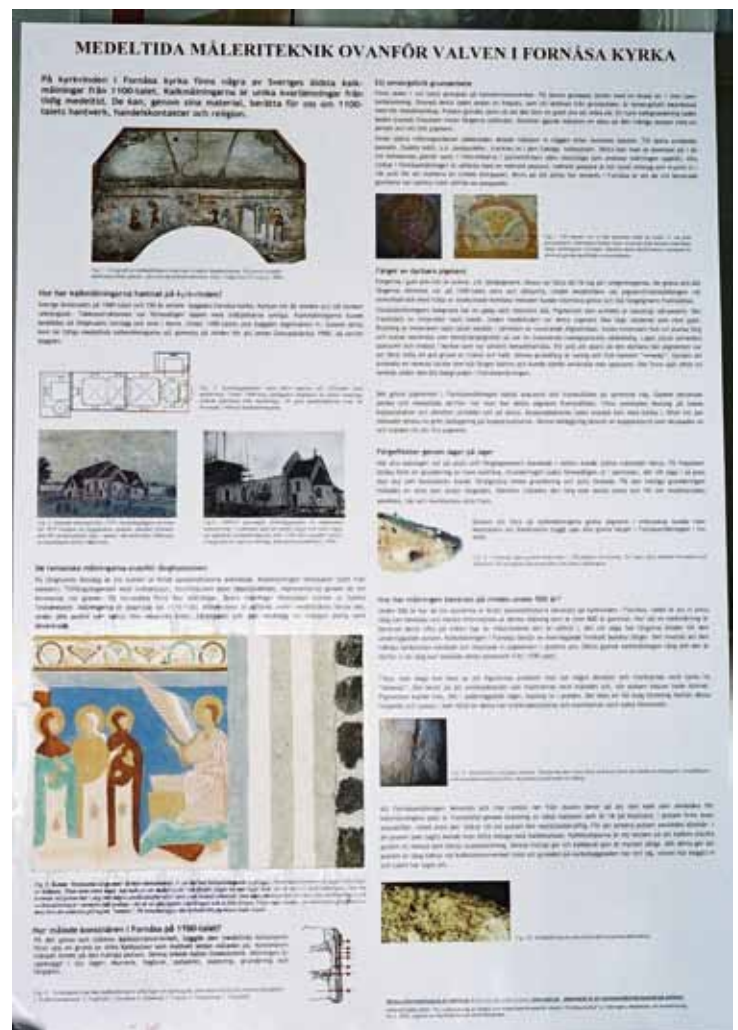
An example of an information board at site that enabled a presentation and a knowledge transfer about the hidden information of retrieved investigation results at Fornåsa church (photo A. Henningsson)

The painting technological findings can give new dimensions to the hidden paintings in the attics to the community. Through the simple visualization of large printed photos of toll marks, layers and used materials, it was possible to present a story about the creation of the painting. A pedagogic reconstruction of the creation process was visualized by using real materials integrated with an information board to accompany the photos. All this information was accessible to visitors in the church porch.

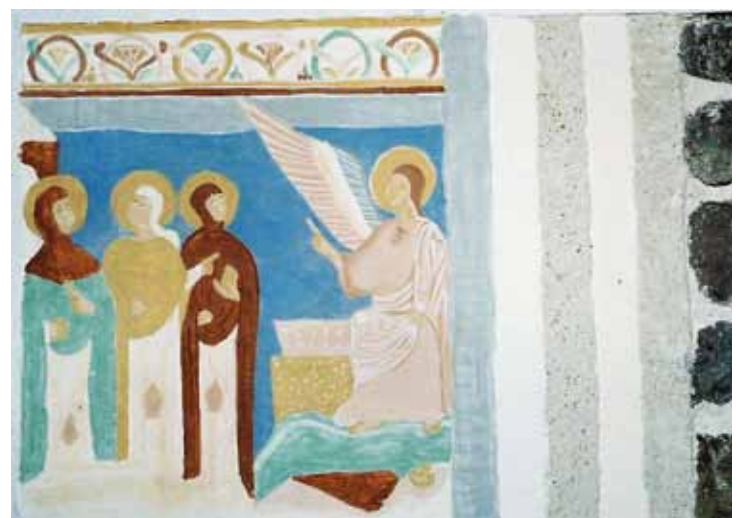
The pedagogic reconstruction of the painting technique and execution process using real materials and integrated in the information board (photo A. Henningsson)
